Double Lap Shear Testing of Coating Modified Ice Adhesion to Liquid Oxygen Feed Line Bracket, Space Shuttle External Tank

May 2006

Final report

Prepared for National Aeronautics and Space Administration

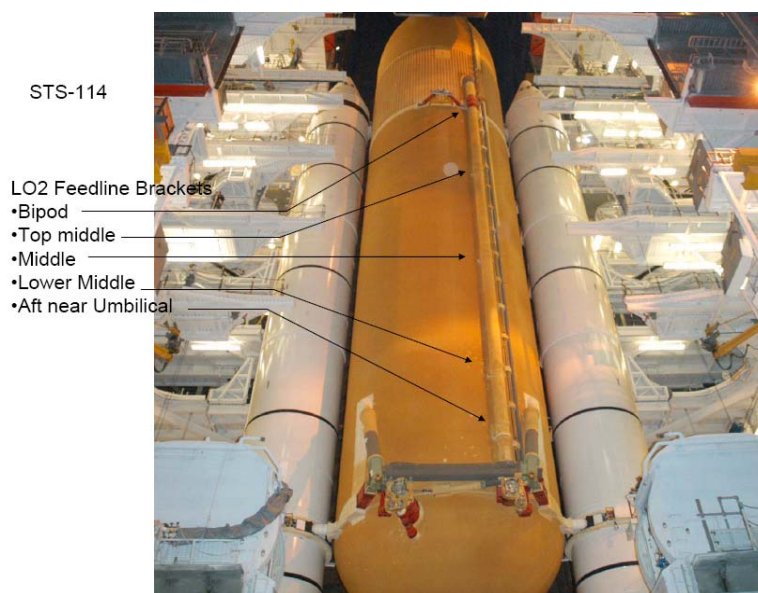
Figure 1. Locations of the liquid oxygen (LO₂) feed line brackets on the external tank of the space shuttle.

Ice is one form of debris from the external fuel tank of the space shuttle that can be liberated during launch, potentially causing damage to the shuttle elements. The brackets that secure the liquid oxygen (LO₂) feed line to the external tank are known locations of frost and ice growth during the pre-launch period that follows fuel loading. These aluminum brackets are in contact with the cryogenic liquid fuel tanks, and the exposed surfaces are uninsulated to allow space for thermal flexing of the feed line. Ice grows on the brackets primarily as a result of initial frost formation, followed by condensate rundown and subsequent freezing within the frost. If liberated, this bracket ice is a source of debris that is a threat to the shuttle elements. The locations of the feed line brackets are indicated in Figure 1. Figure 2 provides a close-up view of a bracket with ice present, and Figure 3 is an engineering drawing of the bracket with the exposed surface indicated in blue.

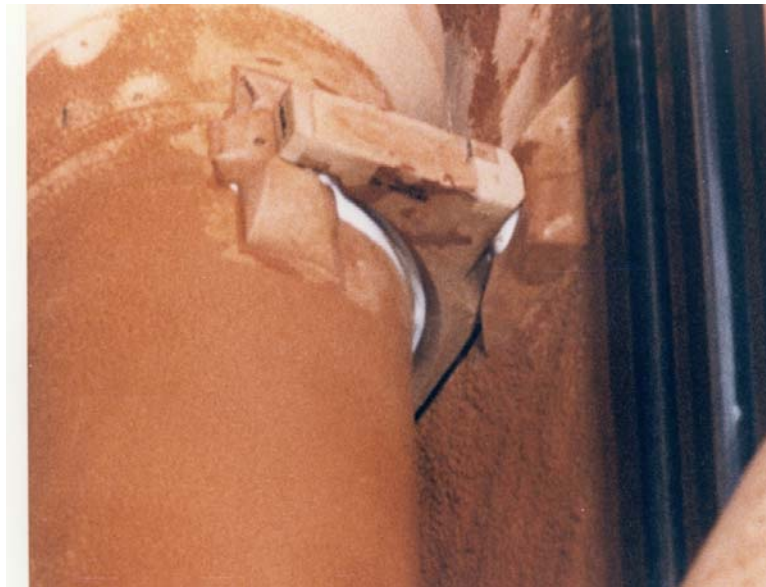
Figure 2. Ice frost on a LO₂ feed line bracket of the external tank.

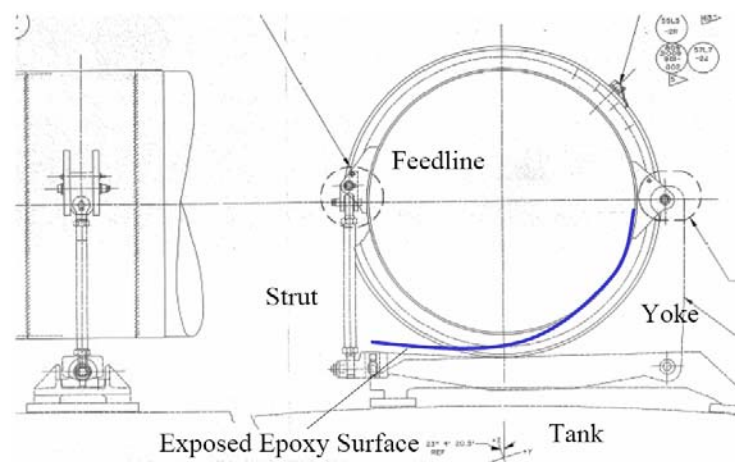
Figure 3. Engineering drawing of the feed line bracket and associated structures. The uninsulated surface is depicted in blue.

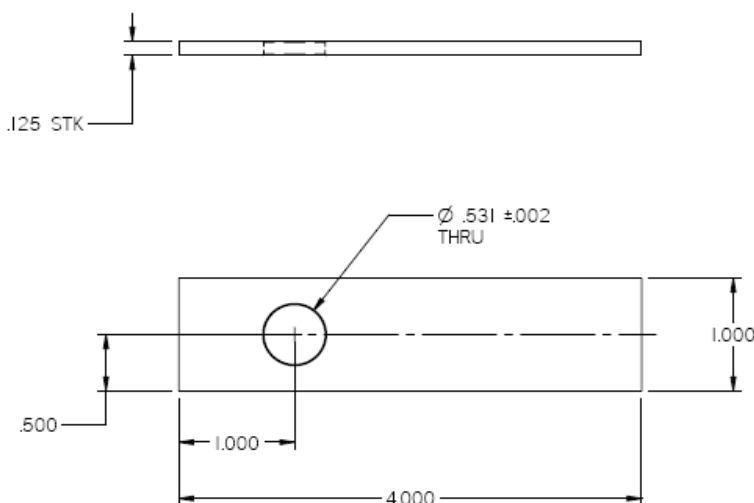
Figure 4. Engineering drawing of CRREL coupon design for ice adhesion testing.

Preliminary discussions of the NASA-NESC ice mitigation team led to selection of the single lap shear test, following ASTM (2003) D3164-03, as a simple experiment to evaluate and quantify candidate coating materials for their bracket ice release potential. Coupon size and shape for this test were designed at CRREL (Fig. 4), and coupons were produced by NASA-MSFC using aluminum painted with epoxy (Koropon) to simulate the exposed metal surface of the feed line bracket. The Koropon Primer is an amine-cured epoxy and the resulting coating possesses hydroxyl chemical groups (moieties). Each test specimen was composed of two coupons bonded together by ice 0.125 in. thick with an area of 1 by 1 in.

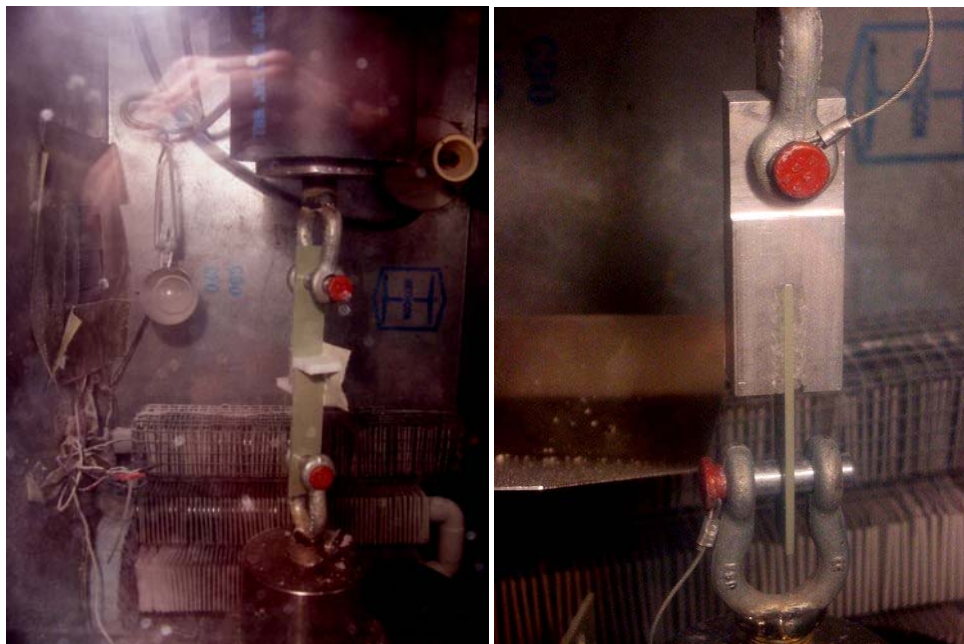
Figure 6. (left) Single lap shear specimen mounted in the MTS machine inside the test chamber, and (right) double lap shear specimen in the same configuration.

The single lap coupon pairs were mounted in the MTS machine between the loading platens using a clevis and pin setup, and pulled longitudinally (Fig. 6). A data acquisition system collected and stored temperature, deformation, and load data through time. The data from each test were immediately analyzed for peak load and total work, and load–displacement, load–time and displacement–time data were plotted.

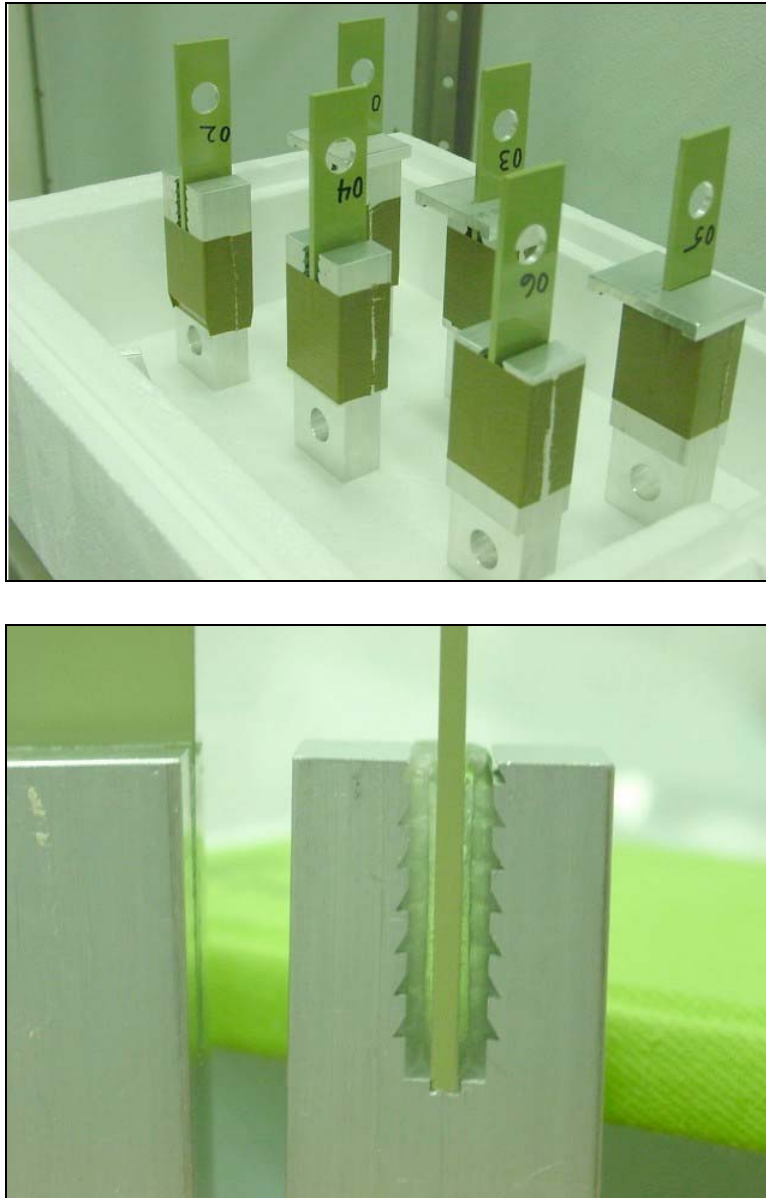
Figure 7. Double lap shear molds formed with tape (top). These molds are filled with water in a +1°C coldroom. The sample caps (back row) hold the coupons in alignment during the freezing process. Close-up of double lap shear sample cooling in the coldroom after freezing in the cold box (bottom).

Subsequent preliminary double lap shear tests on 24 May evaluated different holders and strain rates. The aluminum holder shown close-up in Figure 7 was selected for use, except that the downward slanting roughness elements were replaced by an equal number of upward slanting roughness elements. A low and constant deformation rate of 0.005 in./min was used for about the first 10 minutes of each test, followed by a 20× higher rate of 0.1 in./min until a total displacement of 0.5 in. was attained. Samples in the double lap test configuration were robust, with none being damaged during handling in the preliminary tests. There was no visible damage to the Koropon coupon surfaces as a result of the testing. On the basis of these positive results, the ice mitigation team decided to proceed with double lap shear testing of many candidate coating materials in what became the first of three test phases.

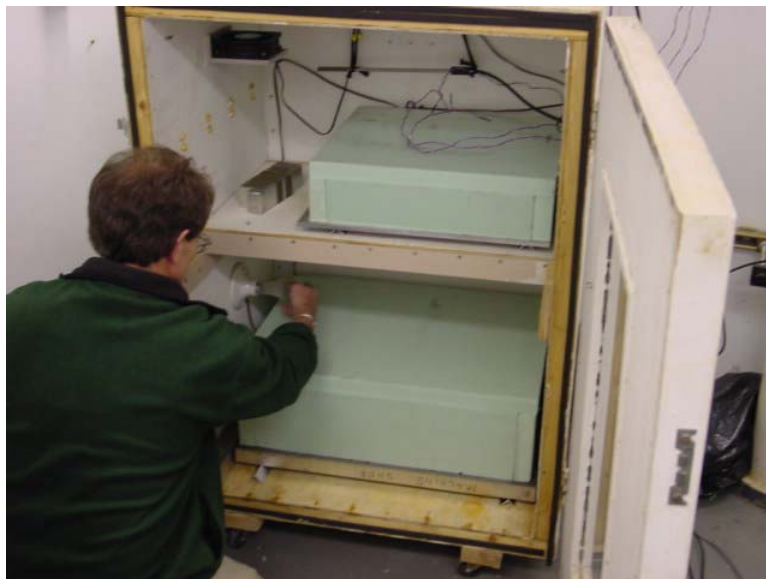
a. Placing the samples.

b. Insulated cover to isolate the samples inside the cold box for maximum temperature stability.

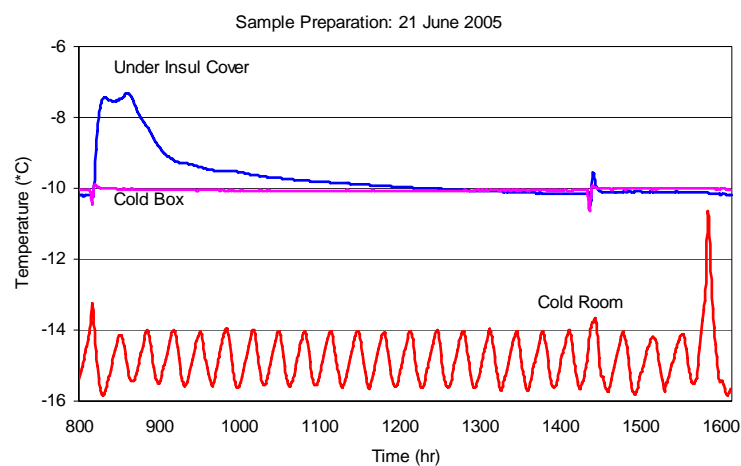
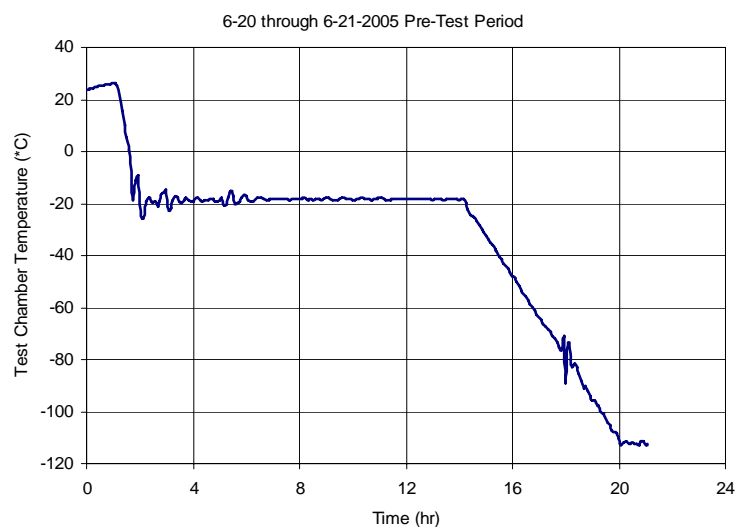
a. Sample ice growth under the insulated cover inside the cold box (samples removed at 1420), the cold box itself, and the larger coldroom outside.

b. Test chamber with temperature decrease beginning at 1420 with initial -20°C attained at 1520 on 20 June. The linear temperature decrease begins at 0320 on 21 June, an LN_2 tank is changed at 0700, arrival at -112°C at 0900, and test initiation after 1000.

The temperature regimes of 20 and 21 June 2005, given in Figure 9, are typical of the patterns associated with sample freezing and subsequent temperature reduction. Samples were placed in the cold box just after 0800 on 21 June, and the heat of the samples raised the temperature under the insulating cover to almost -7°C . This maximum temperature was maintained for about 30 minutes, followed by an asymptotic temperature decrease over a 4-hour period. Sample freezing and temperature equilibration at -10°C were complete by 1300. Samples were removed from the cold box at 1420, as reflected in a temperature oscillation both under the cover and inside the cold box. Coldroom temperatures were not as stable as those of the cold box, oscillating $\pm 1^{\circ}\text{C}$ continuously about a mean of -15°C , with defrost cycles causing larger excursions just after 0800 and just before 1600. The test chamber temperature reduction for the samples prepared the previous day is also given in Figure 9. Cooling of the chamber for the test on 21 June began at 1420 on 20 June. The chamber attained the holding temperature of -20°C at 1520, and maintained that temperature until the linear temperature decrease began at 0320 on 21 June. A change of the LN_2 tank at 0700 briefly disturbed the temperature decrease, which then continued until the -112°C test temperature was attained at 0900 on June 21. Stable temperature of the test chamber was then maintained until testing began after 1000 and throughout the testing. A second LN_2 tank change and corresponding temperature fluctuation occurred during the testing.

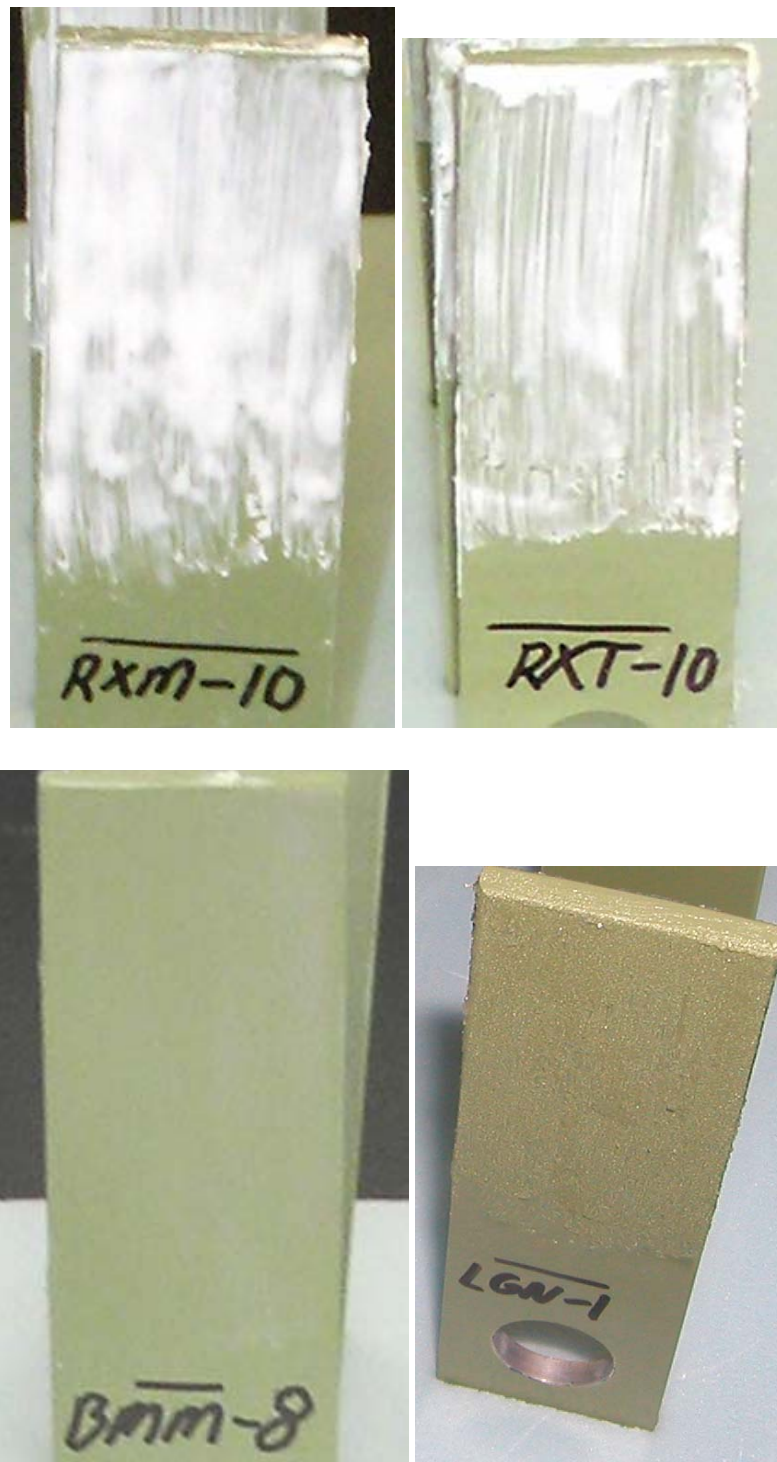
Figure 10. Selected phase 1 coated coupons prior to testing (clockwise from top left): Rain-X with maximum MP-55, Rain-X with typical MP-55, NAPA lithium grease with Knox gelatin, and Braycote 601EF with maximum MP-55 on an abraded surface.

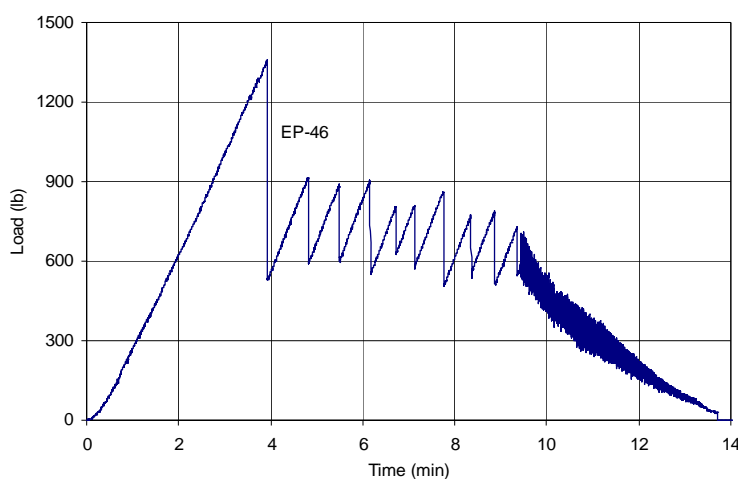
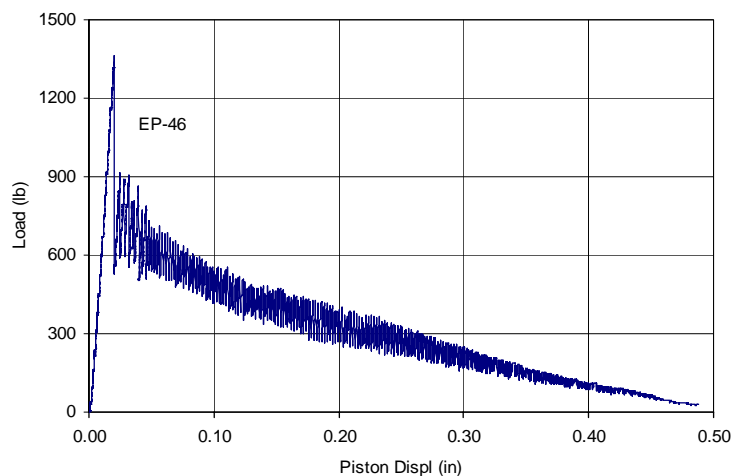
a. Load–time response.

Figure 14. Responses of control sample EP-46 in double lap shear testing.

b. Force-displacement response.

The control tests were characterized by a series of audible ice fractures. The load typically increased linearly with time until a primary ice fracture occurred, greatly reducing the load. Subsequent linear load increases would be followed by subsequent fractures and sharply reduced load, producing a periodic “saw-tooth” pattern. The high strain rate later in the test served to accelerate the ice fracture process. The load–time and load–displacement responses of a particularly strong control from a test on 7 June 2005 are given in Figure 14. The diminishing amplitude of the load and scale of the saw-tooth with displacement and cumulative damage to the sample are evident. The change in strain rate at 9.5 minutes in this test, EP-46, greatly shortened the cycle of ice fracture and load recovery (Fig. 14). Post-test evaluation revealed extensively fractured ice that remained strong enough to hold the coupon against the force applied by an observer. Ice adhering to the coupon after testing, termed ice collars, was common for control samples.

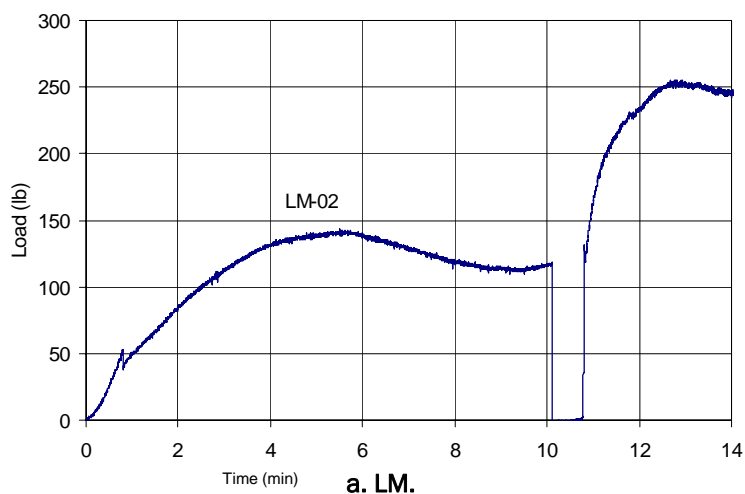
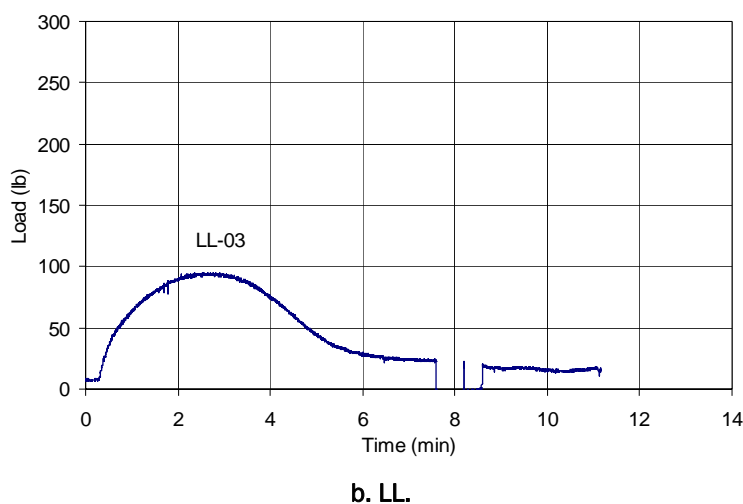
a. LM.

Figure 15. Load-time responses in double lap shear testing of representative lithium grease coated samples.

Figure 15 (cont'd). Load–time responses of representative lithium grease coated samples in double lap shear testing.

The lithium grease coated coupons without additives displayed extremely smooth load response with time. The load-time responses of representative samples from LM and LL sample groups are given in Figure 15. The LL coating displayed much lower peak loads and less total work than the LM coating, indicating that more lithium grease is not better at cryogenic temperatures. The high strain rate later in the tests applied load more rapidly and increased the slope. The LM peak loads increased significantly with the strain rate, but the LL peak loads did not. A post-test observer easily moved both the LL and LM coupons by hand.

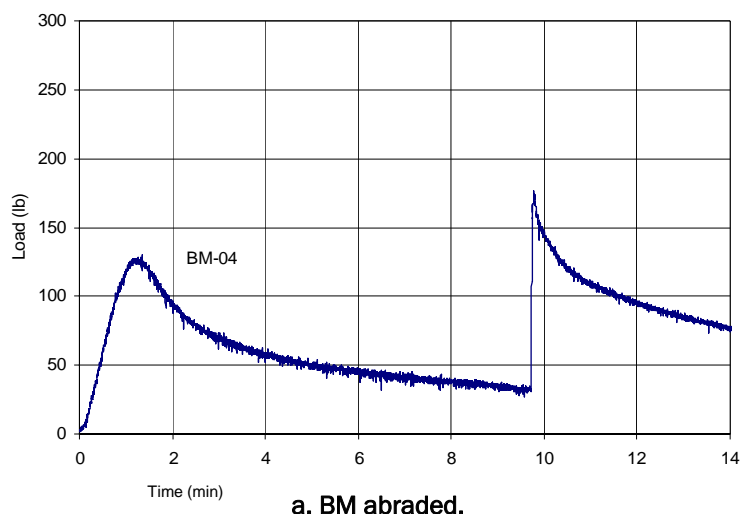
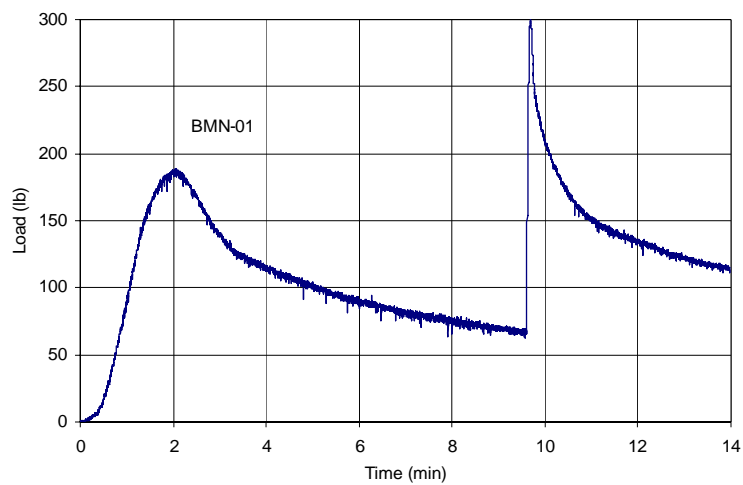
Figure 17. Load–time responses in double lap shear testing of representative Braycote mixed with MP-55 coated coupons.

b. BMN unabraded.

Figure 17 (cont'd). Load-time responses of representative Braycote mixed with MP-55 coated coupons in double lap shear testing.

Following the tests there was significant coating material retained on all coupons. The planar ice interface was largely undamaged on most Braycote samples. Most BUM and BUT coupons did not retain ice collars, while the opposite was true for the BM coupons, and all BMN coupons had ice collars. The overall consistency and performance of the BUM coating indicate superiority of UF-8TA over MP-55 when mixed with Braycote. However, as UF-8TA was not mixed with other binders, their potential performance improvements remain unknown.

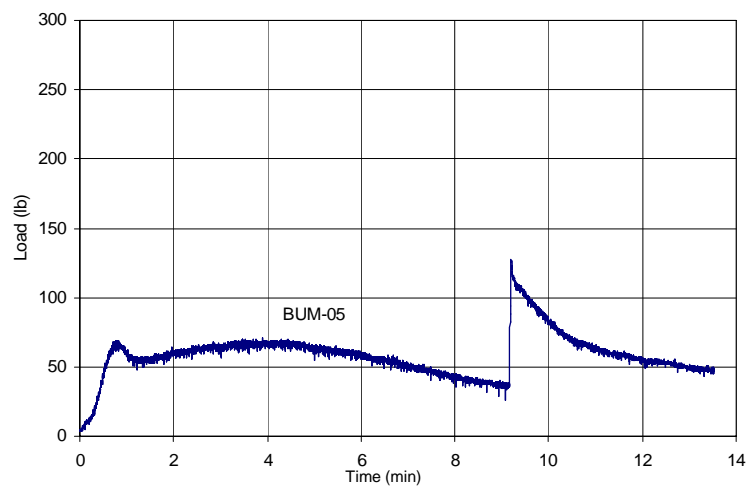
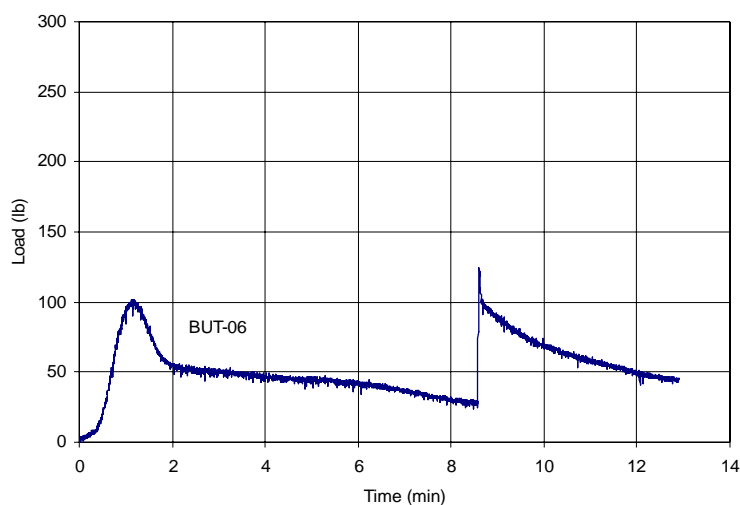
a. BUM maximum UF-8TA.

Figure 18. Load-time responses in double lap shear testing of representative Braycote mixed with UF-8TA coated on abraded coupons.

b. BUT typical UF-8TA.

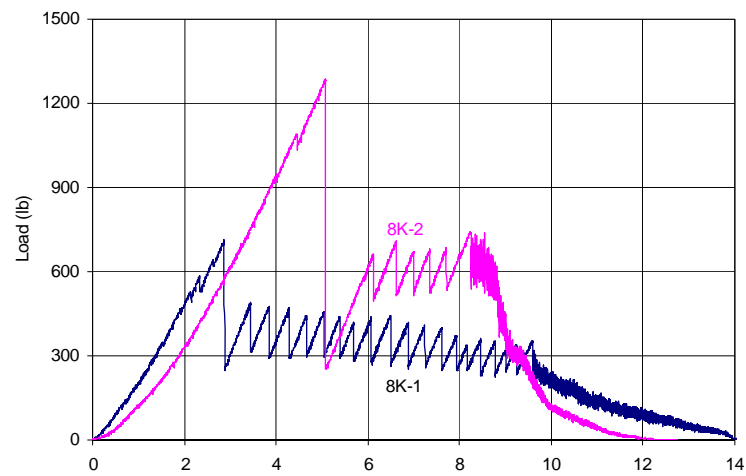
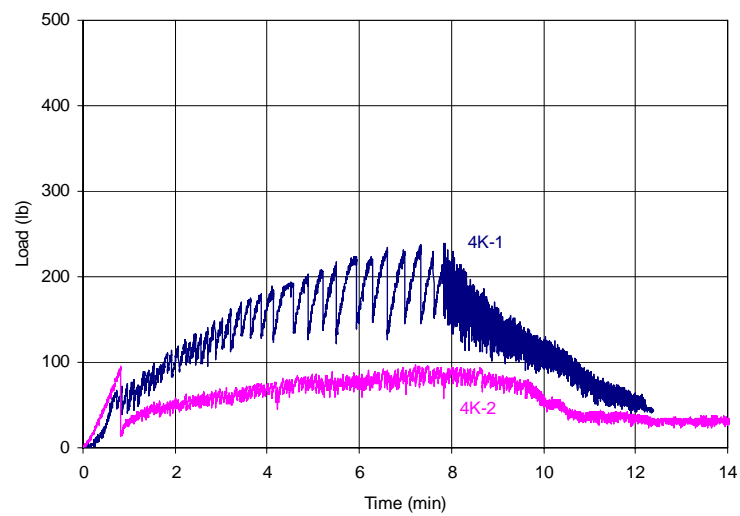
a. UNC 8K.

b. UNC 4K.

Figure 19. Load-time responses in double lap shear testing of UNC coated coupons.

UNC provided seven coated samples for double lap shear testing. Load–time data for the 8K and 4K samples are given in Figure 19, and the 1/4K and 1K results are given in Figure 20. Peak load and total work for this entire group of samples are compared in Table 5. The 8K load–time data with a high initial peak followed by a saw-tooth and finally decaying loads at the high strain rate closely resembled the signature of the controls. The load–time characteristics of the 4K coating differed between the two samples tested, and also differed from the 8K signatures. The 4K peak-load and total work were significantly reduced relative to the controls, providing the maximum reduction in adhesive strength of this group. The 1/4K coating was nearly as effective as the 4K coating, with comparable total work. The load–time signature of both 1/4K samples shared common characteristics. Finally, the data for the 1K coating indicate less effectiveness than both the 4K and 1/4K coatings, resembling load–time, peak load, and total work of the 8K coating. Post-test analysis revealed that the 8K ice samples were totally destroyed with no residual strength, while the 4K and 1/4K ice sustained some fracturing. The 1K–ice sample was also significantly fractured during testing, placing it between the other two conditions. The UNC coatings as a group did not achieve the performance of the better coatings.

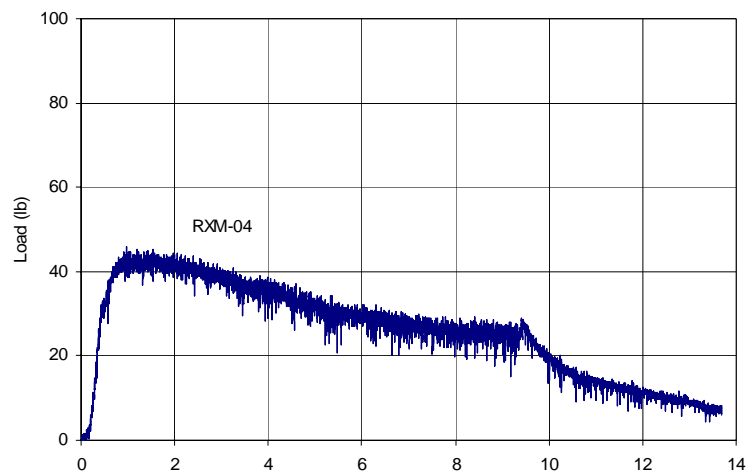
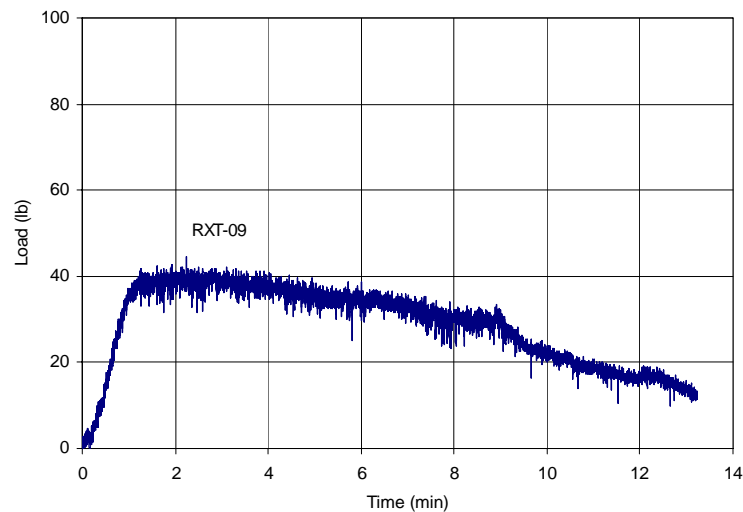
a. RXM maximum MP-55.

b. RXT typical MP-55.

Rain-X was tested in two variations in phase 1, the first with the “maximum” amount of MP-55 in the mix (RXM), and the second with the “typical” amount (RXT). Representative load–time results for each group are given in Figure 21. The shape and character of the Rain-X load–time data were similar for samples in both groups, and overall performance was consistent and outstanding. Diminished load in response to increased strain rate was typical for both RXM and RXT samples. Post-test analysis revealed smooth ice at the interface with the coupon that did not show evidence of damage from testing, and coupons moved easily by hand. However, significant amounts of coating retained on the ice surface indicated both failure in the coating and the potential for loss of effectiveness with repeated cycles of ice formation and release. Peak load and total work data summaries for these cycle 1 tests are given in Table 6.

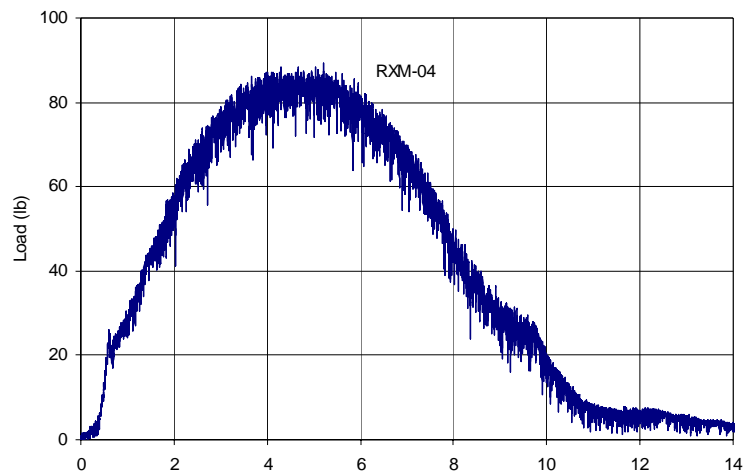
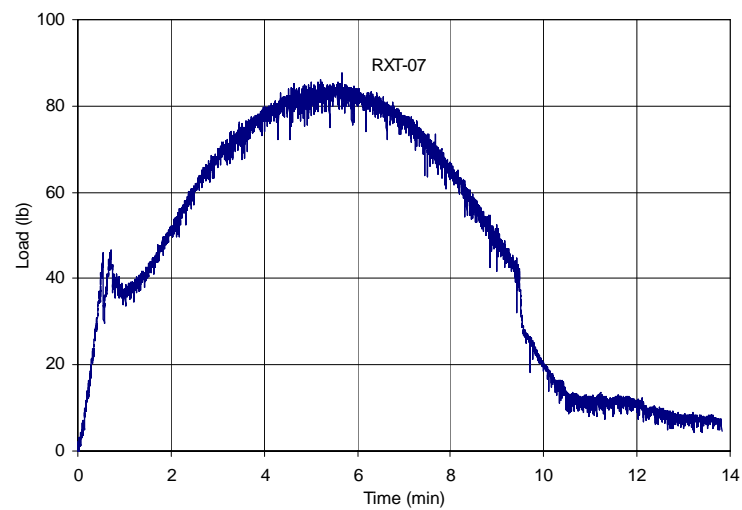
a. RXM maximum MP-55.

b. RXT typical MP-55.

Figure 22. Load-time responses in cycle 2 double lap shear testing of representative Rain-X mixed with MP-55 coated coupons.

Five RXM and five RXT coupons that performed nearest the average for work and peak load in their respective groups were selected for a second cycle of testing. Representative load–time results for each group in cycle 2 are given in Figure 22. A change in shape of the load–time response can be noted between test cycles 1 and 2. The total work and peak load results of cycle 2 tests are also given in Table 6. The average total work for RXM samples remained constant, but variability in work increased. Average peak loads of RXM coated coupons increased, but peak load variability, as measured by the coefficient of variation, decreased. For RXT samples both peak load and average total work increased. Unlike cycle 1, RXM performance in cycle 2 was marginally better than RXT. Post-test sample analysis again had generally planar ice interfaces with no evidence of damage. Additional coating was retained on the ice surface, and very little coating remained visible on the coupons.

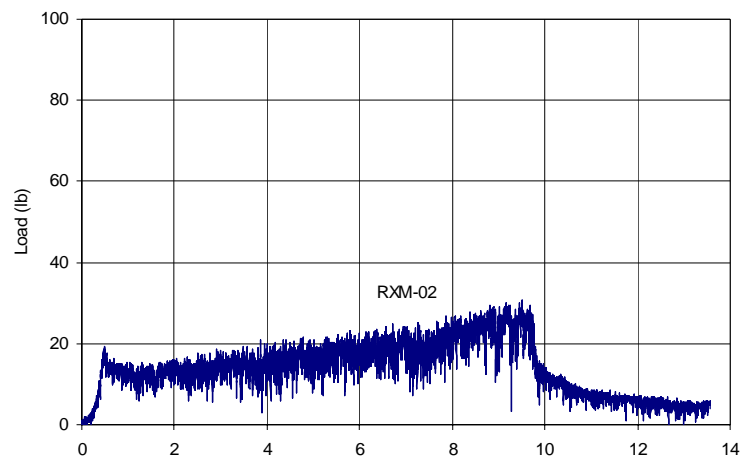
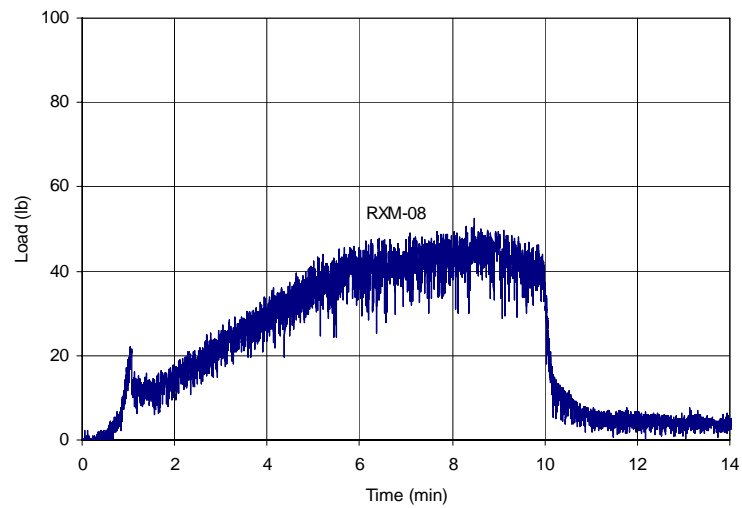
a. RXM-02.

b. RXM-08.

The best two coupons based on cycle 2 results, RXM-02 and -08, were re-tested a third time and their load–time results for cycle 3 are given in Figure 23. Total work and peak load recorded in these cycle 3 tests compare favorably to the cycle 1 and 2 results. Peak load and total work results, specific to these two coupons, are given over the 3 cycles in Figure 24. Peak load increased from cycle 1 to 2, but returned to the cycle 1 level in cycle 3. Total work diminished between cycles 1 and 2, and remained low in cycle 3. The question of RXM coating durability is not answered fully by these phase 1 results, but outstanding performance and indications of durability are promising.

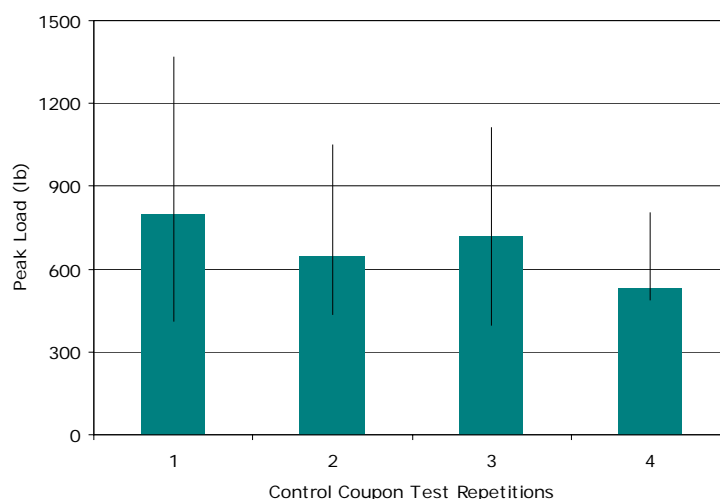
Figure 25. Summary plot of control coupon test repetitions. The x-axis indicates the number of times a coupon was tested; the height of each bar represents the median peak load of the population, while the error bar indicates the corresponding minimum and maximum.

tion is normally distributed, and sample sizes of 2, 7, 10, and 14 are not large enough to make conclusions about the nature of the probability density function (PDF). Therefore, a non-parametric method, the standard Kruskal-Wallis test (Siegel and Castellan 1988, Zar 1999), was used instead. The results of this test show that at the 95% confidence level ($\alpha = 0.05$) the null hypothesis, that the means of all of the populations are the same, is true ($p = 0.147 > 0.05 = \alpha$).

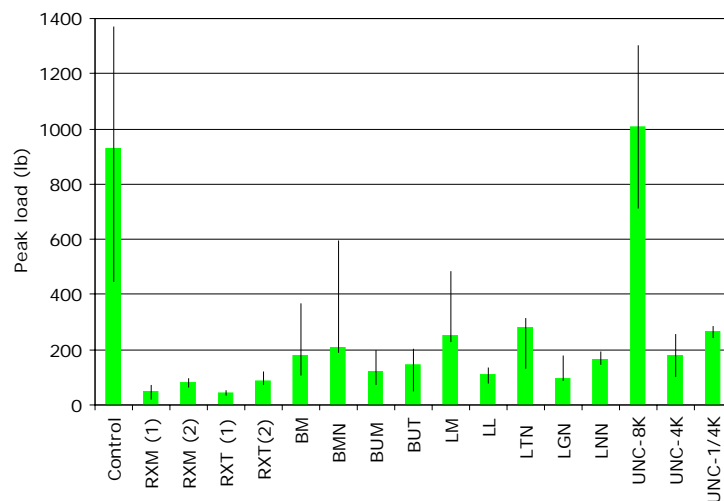
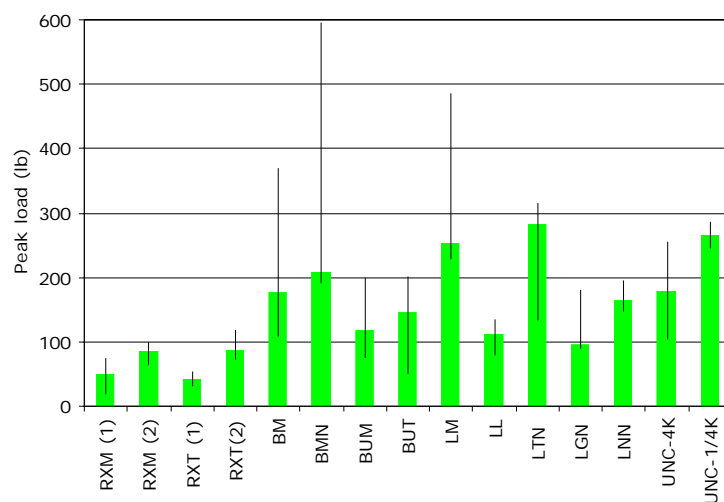
a. All controls and coatings tested in phase 1.

b. Expanded scale, not including controls and UNC-8K coating.

Having established that the control coupons did not significantly degrade when subjected to repeat testing, the coated samples can now be compared to the controls. Peak load data for all phase 1 test series are summarized in Figure 26. Each bar represents the median of the series, and the error bars depict the corresponding minimum and maximum peak loads. The null hypothesis of the Kruskal-Wallis test in this case is that the means of all the coatings are the same as that of the control. The results of this analysis show that the null hypothesis is generally false. Only the UNC-8K coating has peak loads that are the same as those of the control. All other coatings have statistically significant lower peak loads, at the 95% significance level, than those of the controls. The Rain-X MP-55 coating performed better in cycle 1 than all of the other coatings evaluated (Fig. 26), but there was no statistical difference between the typical (RXT) and maximum (RXM) formulations of this coating. In the second cycle of testing the Rain-X–

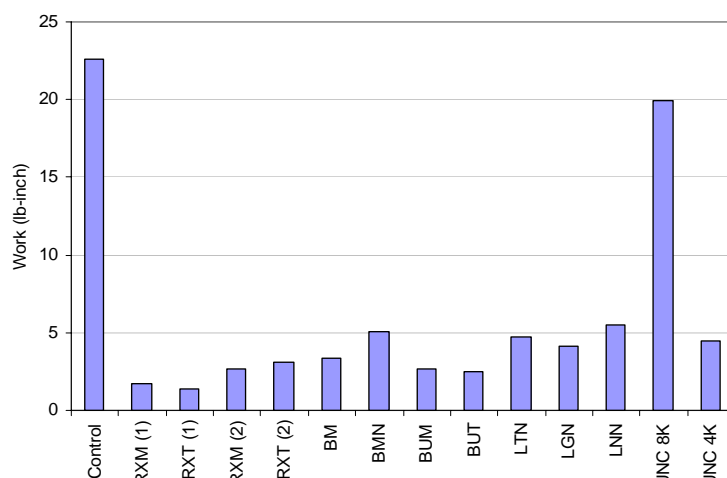
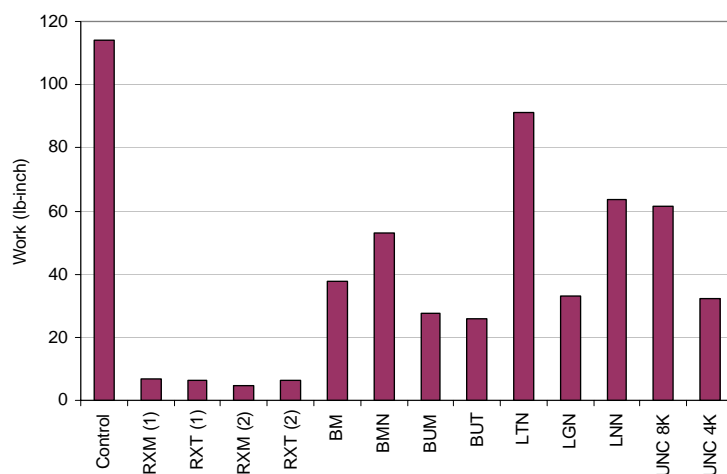
a. Low strain rate.

b. High strain rate.

Figure 27. Work expended for each phase 1 coating.

Mean values of work and power are given for each coating by strain rate in Figures 27 and 28, respectively. At the low strain rate the work required (Fig. 27) is highest for the controls and the UNC-8K coating while the cycle 1 RXM and RXT coatings develop the least work. The work required at high strain rate for the Braycote and lithium grease coatings increase significantly, while both cycles of the RXM and RXT coatings show outstanding performance. The power comparisons given in Figure 28 are much the same as those of work, indicating that variable load application times are not significantly affecting the results. Behind RXM–RXT, the BUM and BUT coatings are next most effective at both strain rates, as measured by both power and work.

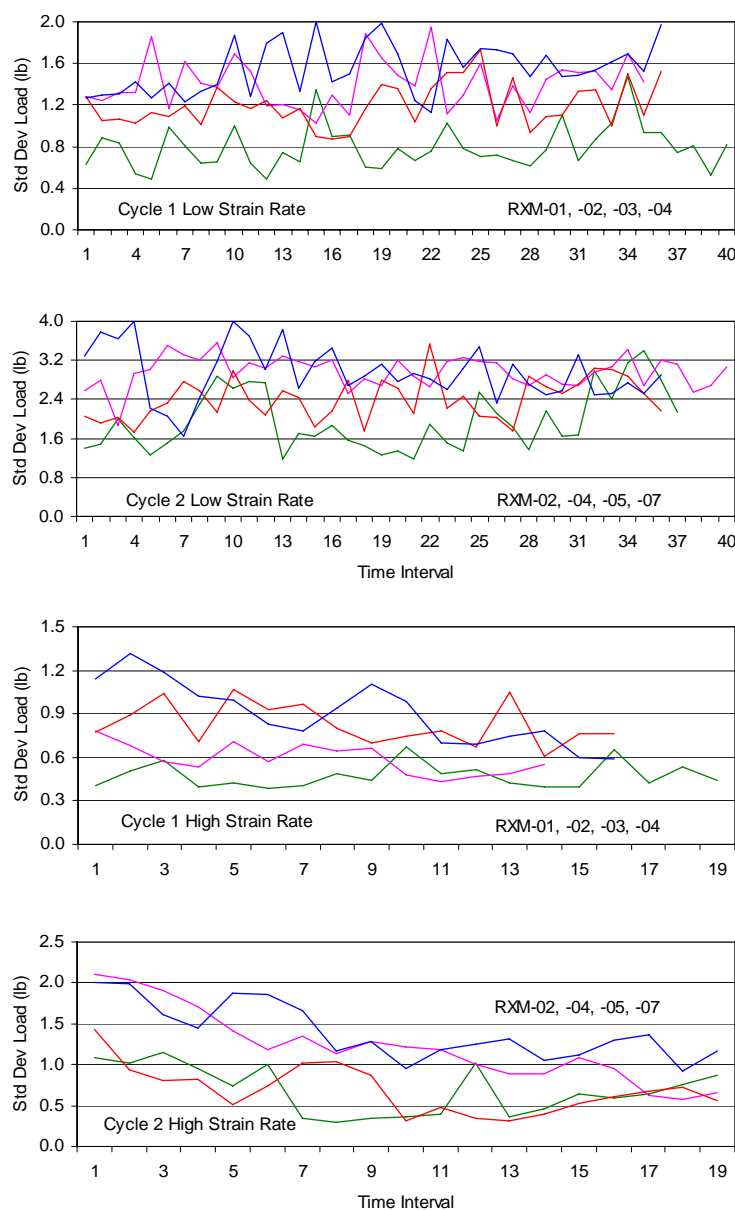
Figure 29. Time sequence of standard deviations from the mean load over 12 sec intervals for several RXM samples: (top) low strain rate, cycle 1; (second) low strain rate, cycle 2; (third) high strain rate, cycle 1; (bottom) high strain rate, cycle 2.

Results of short-term “stick–slip” load variability calculations of several RXM tests are shown in Figure 29, presenting sequential standard deviations from the mean over 12-second time segments, with data subdivided by strain rate and test cycle. At low strain rate there is no trend in the standard deviations with time through the tests, but the cycle 2 values are greater than those of cycle 1. At high strain rate, there may be a slight decrease with time in the standard deviations, and, here, the cycle 2 values are only slightly greater than those of cycle 1. Without important temporal trends, each graph of Figure 29 can be represented by a single value, the average standard deviation over all time intervals of a test and all coupons of a group.

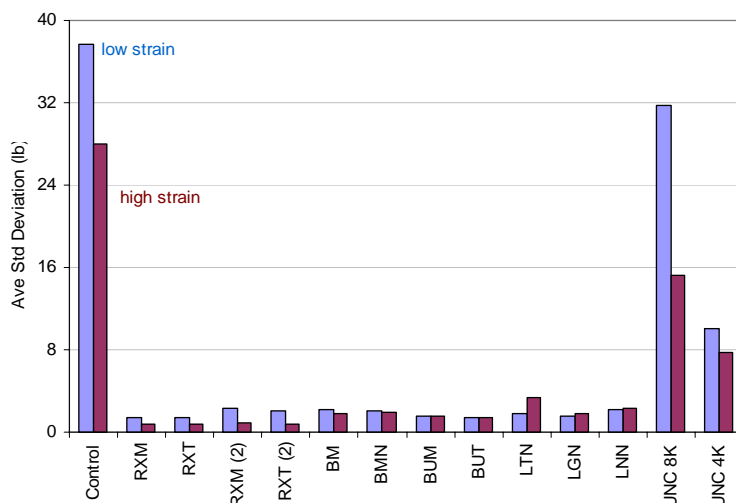
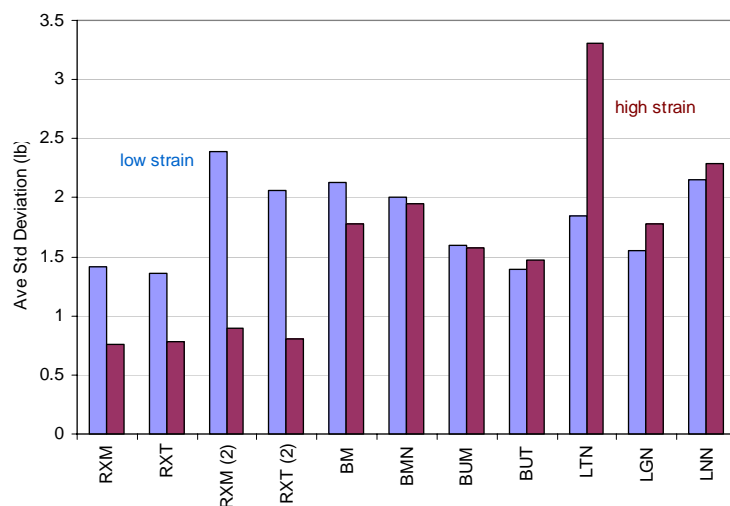
a. Controls and all coatings.

b. Expanded scale with controls and UNC samples deleted.

These averages are presented for all coatings and cycles of phase 1 testing in Figure 30 for both strain rates. Very large average standard deviations of the load are associated with the low strain rate saw-tooth loads of both the controls and the UNC-8K coating. The small decrease in these deviations at the high strain rate was probably a result of accumulated damage to the ice. The average standard deviations are also quite high for both strain rates of the UNC-4K coating, but all other coatings have much

smaller values. It is clear from the expanded scale plot in Figure 30 that the Rain-X coatings displayed larger standard deviations at low versus high strain and for low strain in cycle 2 versus cycle 1, consistent with the more detailed data of Figure 29. Though Braycote and lithium grease loads generally varied with strain rate, the standard deviations, with the exception of LTN, were not strain rate sensitive.

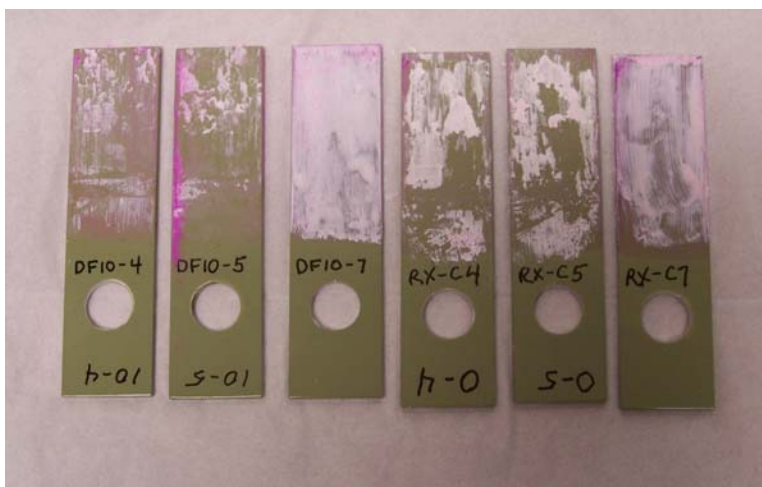
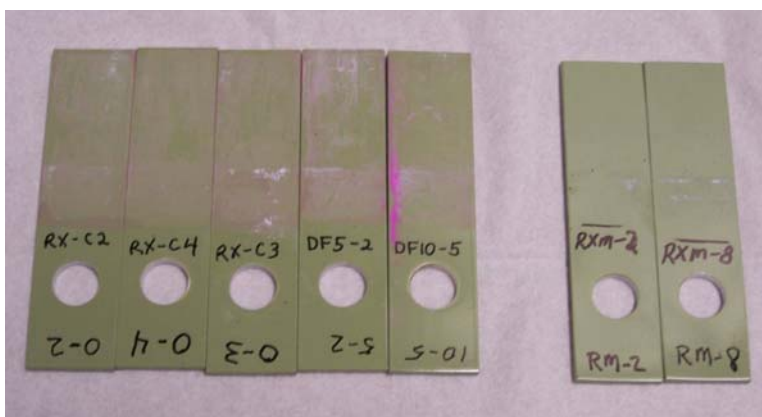
a. After two cycles (10-04, 10-05), after one cycle (0-04, 0-05), and untested (10-07, 0-07) phase 2 coupons.

b. After four cycles (0-02, 0-03, 0-04, 5-02, 10-05) for phase 2 coupons, and after three cycles (RXM-02, RXM-08) for phase 1 coupons.

coupons after two test cycles (10-4, 10-5). Figure 36b compares phase 2 coupons after four test cycles (0-2, 0-3, 0-4, 5-2, 10-5) with phase 1 coupons after three cycles (RXM-2, RXM-8). The progressive loss of coating material from the coupons is evident through the test cycles, and yet coating performance does not degrade. The residual coating that can be seen visually is least for the RXM coupons after three cycles, and yet their total work performance (Table 6, Fig. 24) is better than all phase 2 coatings.

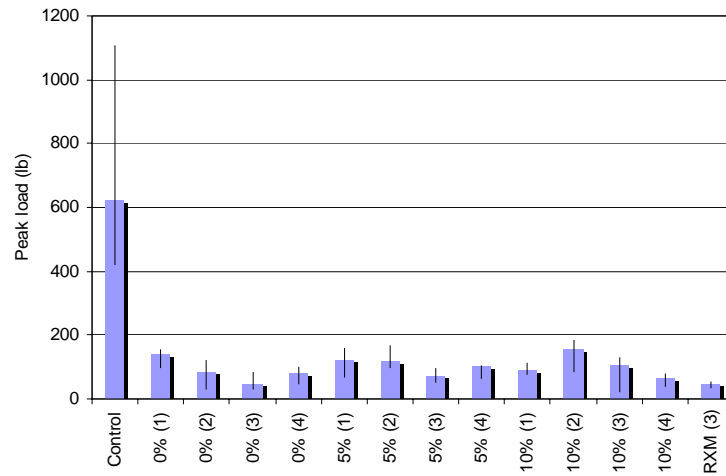
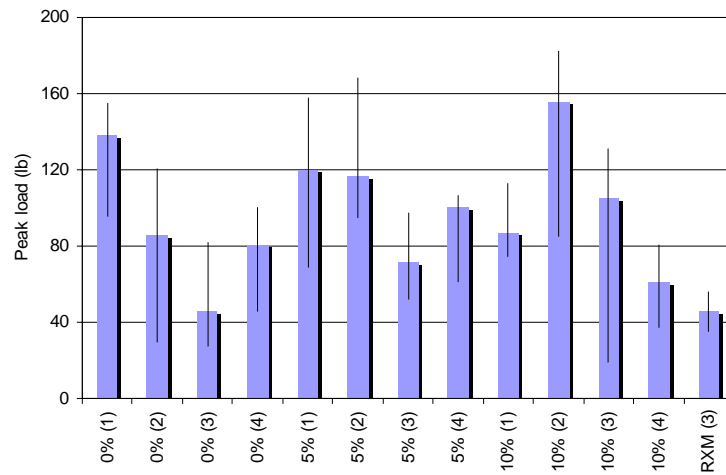
a. All controls and coatings tested in phase 2 plus RXM cycle 3 results for comparison.

b. Expanded scale, not including controls.

Figure 37. Bar charts of peak loads with bar height representing the median peak load of the group, and the error bar indicating the corresponding minimum and maximum.

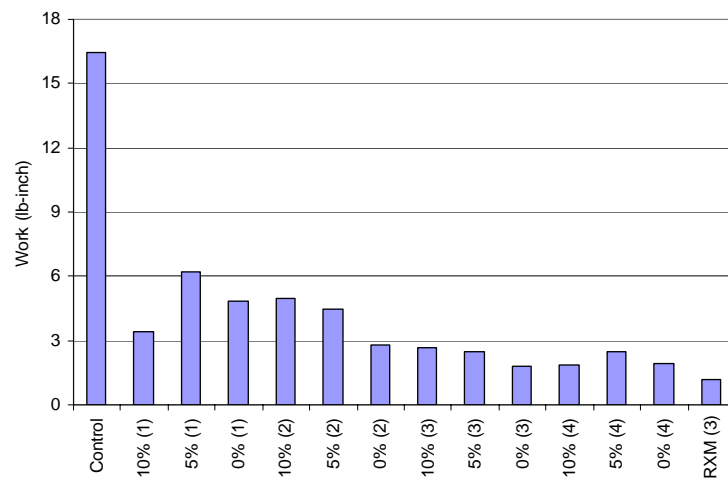
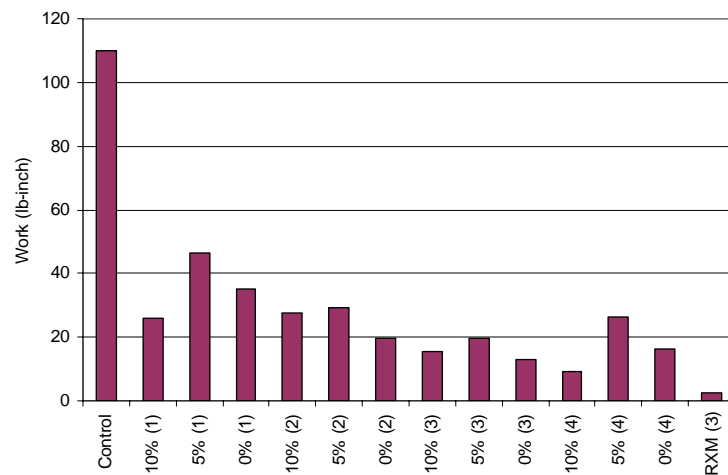
a. Low strain rate.

b. High strain rate.

Figure 38. Average work expended for each phase 2 coating.

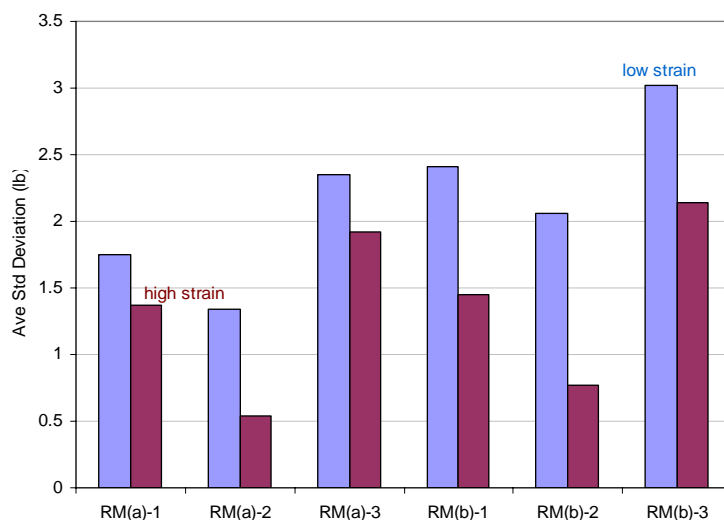
Figure 48. Average standard deviation (lb) from the mean load over successive 12-second intervals by strain rate in phase 3 RM tests, and averaged again for each RM subgroup and cycle.
